Conservatory Roof in Revit Architecture

This White Paper looks at a problem with mullion orientation on Conservatory Roofs in Revit Architecture.

Sloped Glazing and Mullion Orientation

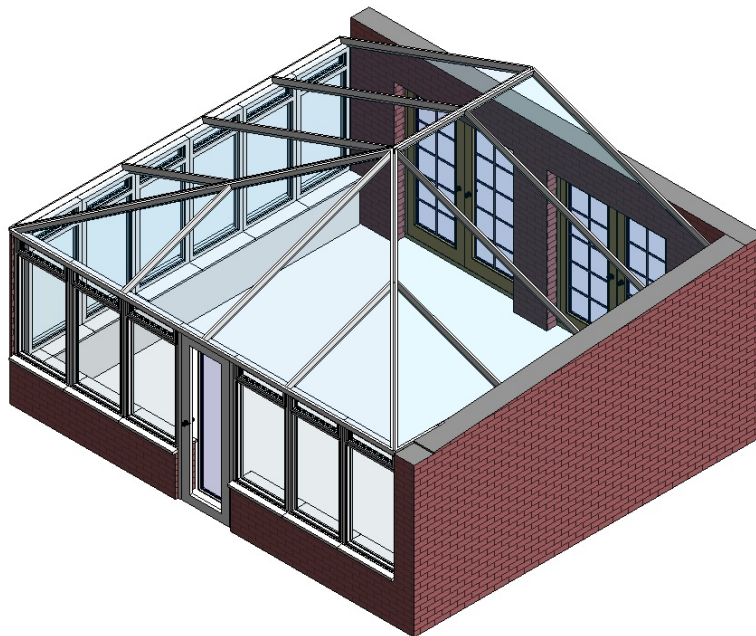
Figure 1 below shows a typical glazed roof construction for an external conservatory.

Fig 1: Conservatory with sloped glazed roof and mullions attached.

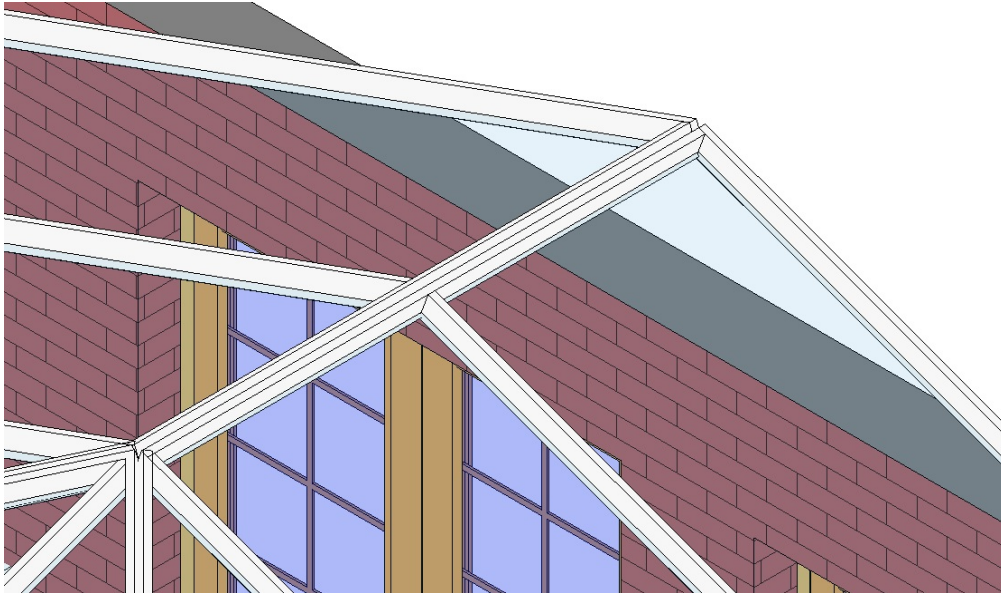
Initially the conservatory looks fine but on closer inspection we can see that there is an issue with the mullions running along the apex of the roof. Refer to figure 2.

Fig 2: Sloped glazed roof apex detail.

The mullions running along the apex of the glazed roof are splayed at an angle but they should be perpendicular.

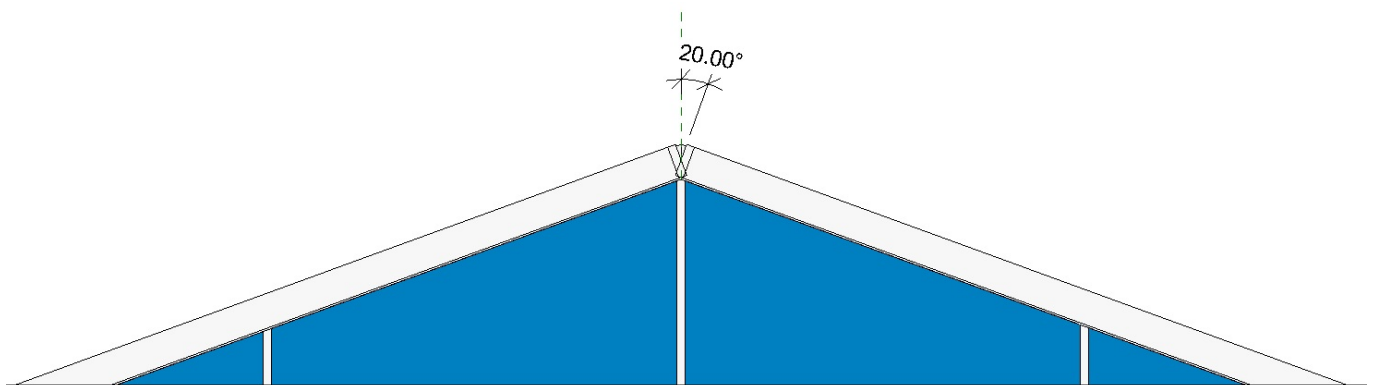
- Find the angle between the mullion and the vertical plane. This can be done in a section view.
- Draw a vertical reference line up from the roof apex and measure the angle between the reference line and the mullion

Fig 3: Sloped glazed roof apex detail (Section View).

To rectify this we need rotate the apex mullions. Refer to figure 3.

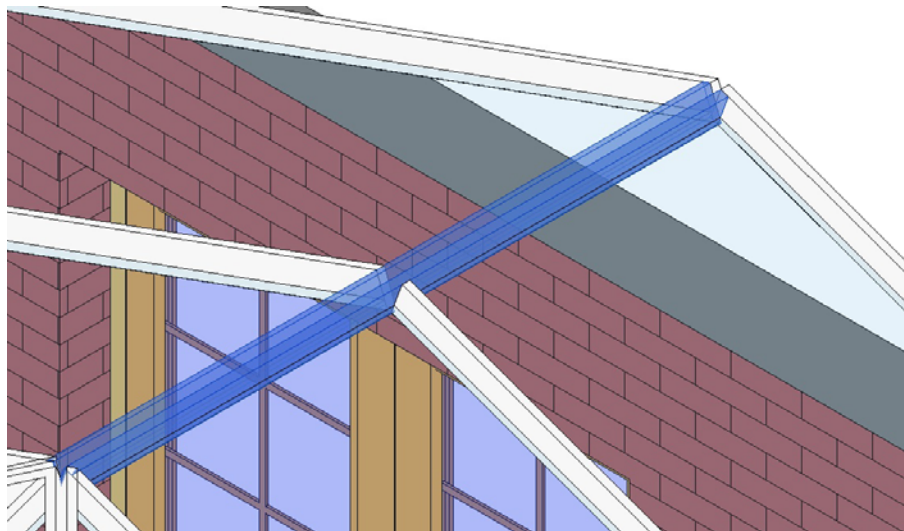
- Select the splayed mullions as highlighted in blue in figure 4 below.
- In the Type Properties Dialogue duplicate and rename the selected mullions. Refer to figure 5.
- In the Type Properties under constraints change the angle to 20 and click OK

Fig 4: Sloped glazed roof apex mullions selected.

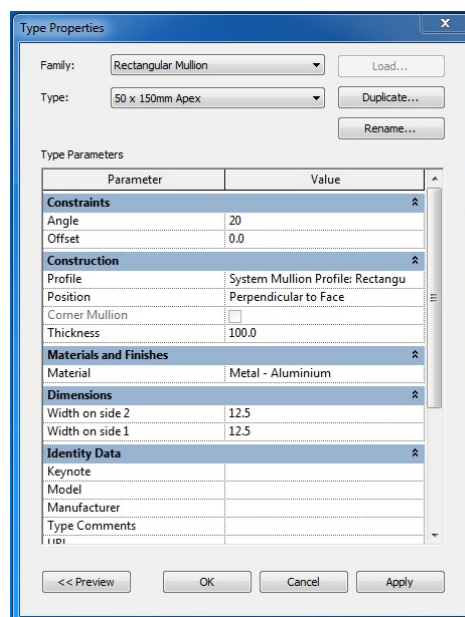
Fig 5: Type Properties Dialogue.

Note: It is necessary to duplicate and rename the mullions whose angle properties are to be changed otherwise the angle of all the conservatory roof mullions would change.

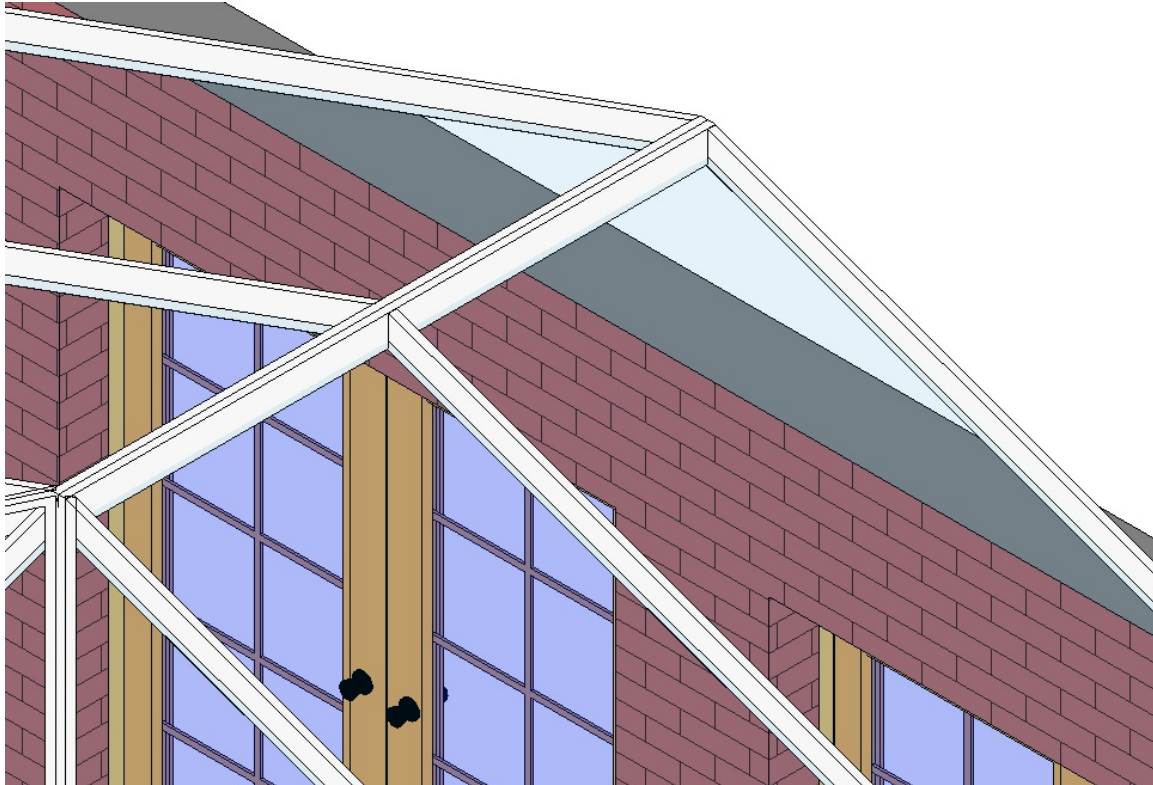
The mullions at the roof apex will now be perpendicular without any gap between them as illustrated in figure 6.

Fig 6: Amended Mullions.
